NSW Centre for
Road Safety

Newell Highway Line-marking Trial

Prepared 22/08/2011

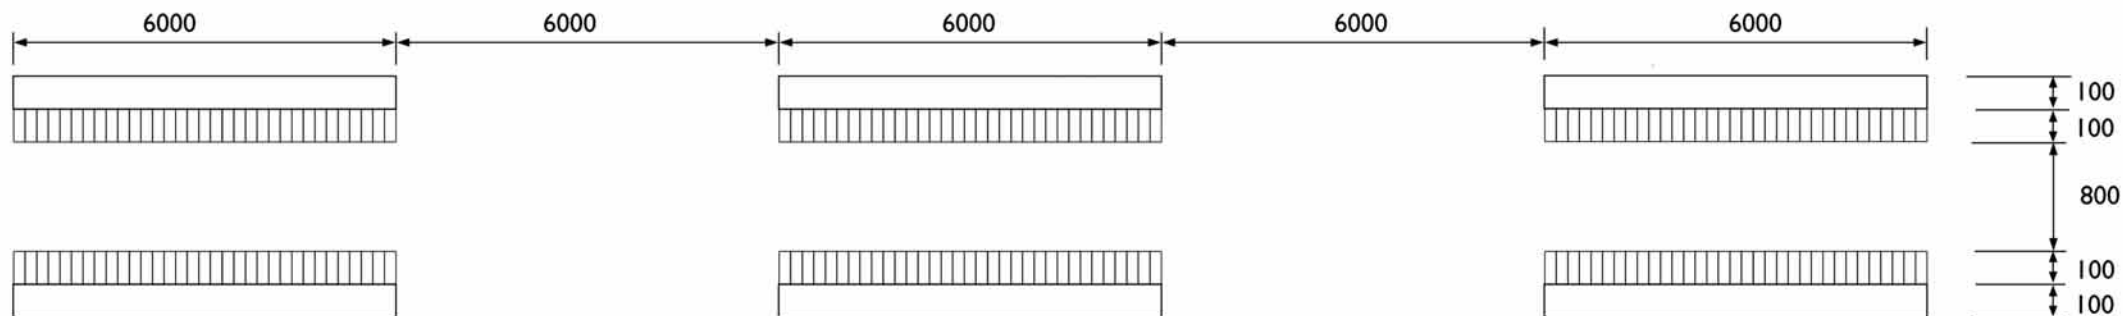
Overtaking permitted in both directions

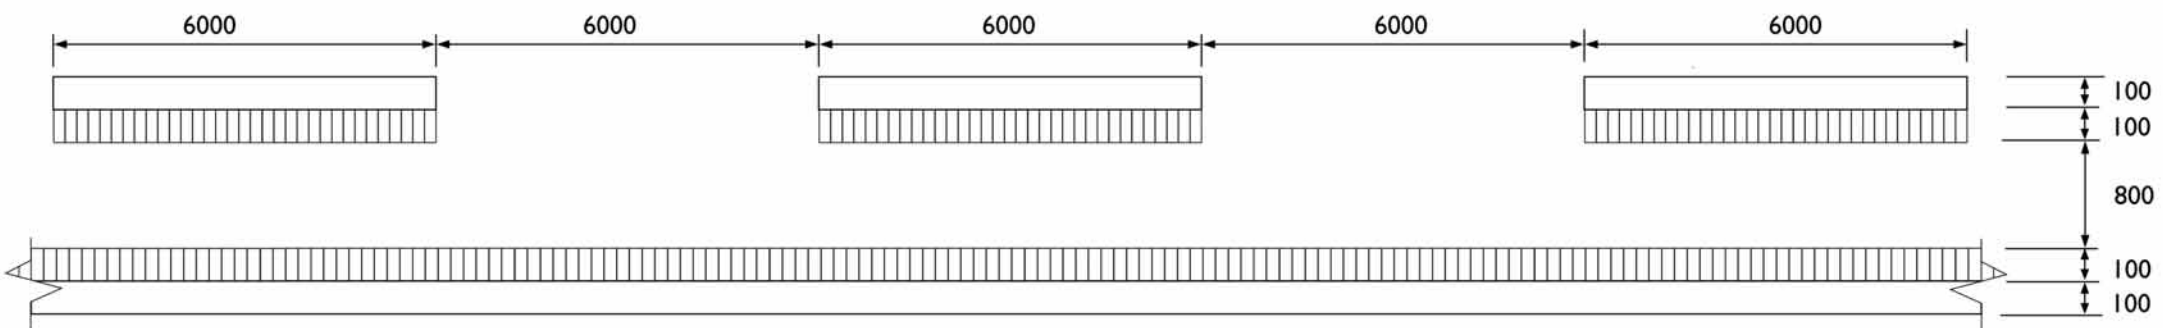
Overtaking permitted in one direction

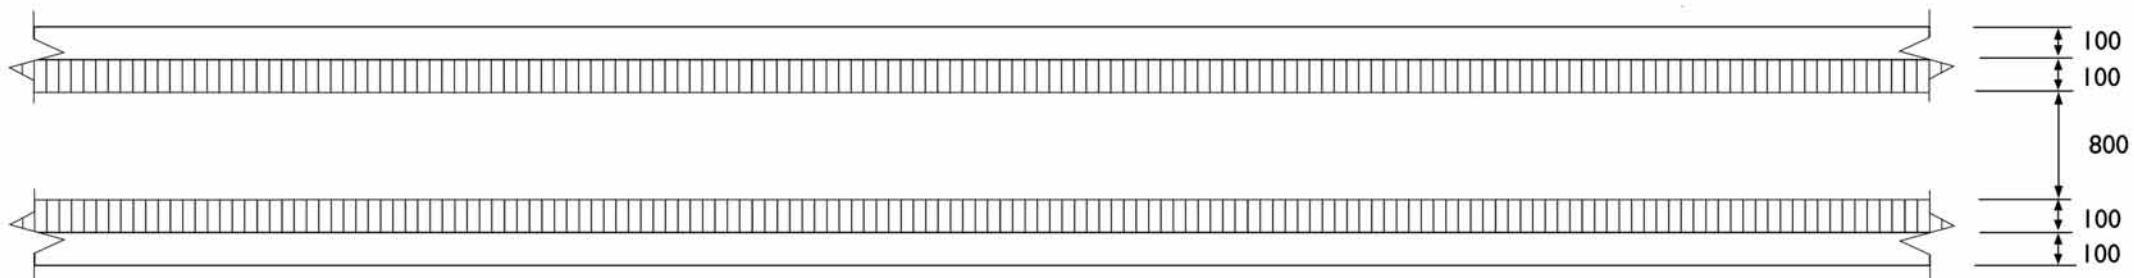
Overtaking not permitted
