NZTA Research Report 526

Stability of motorcycles on audio tactile profiled (ATP) roadmarkings

Neil Jamieson, Bill Frith, Tiffany Lester, Vince Dravitzki

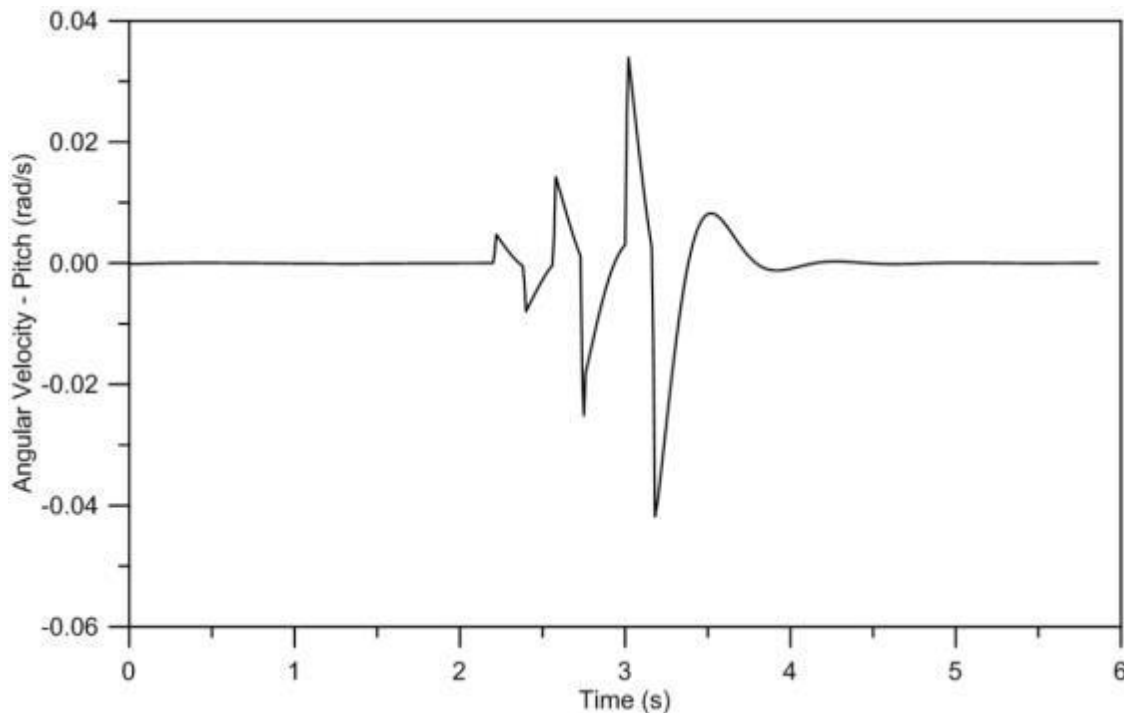
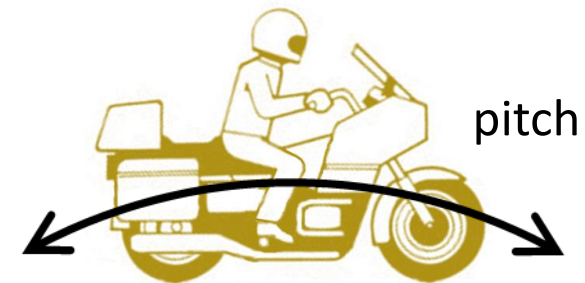
- Response to the details of ATP roadmarkings
  - Motorcycle pitch during travel over single ATP roadmarking ribs of 3 mm, 6 mm, and 9 mm high

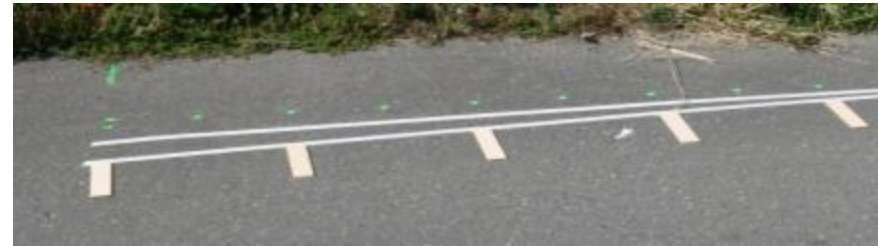
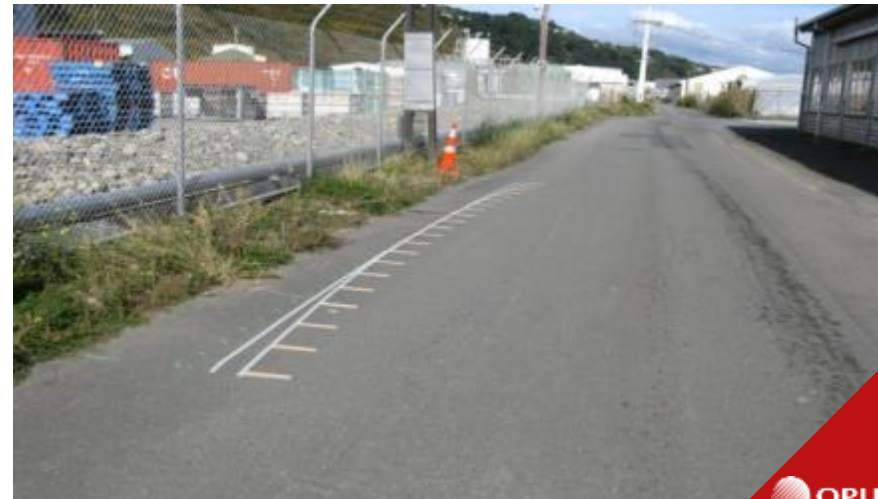
- Full-scale physical testing
  - Instrumented motorcycle  
(gyroscopes, accelerometers, power supply, data acquisition system)
  - Motorcyclist
  - Specified path
  - Without and with ATP roadmarkings
- Equivalent PC-Crash situation:
  - Select same motorcycle
  - Set same motorcyclist weight
  - Set same specified path
  - Without and with ATP roadmarkings  
of same dimensions and layout

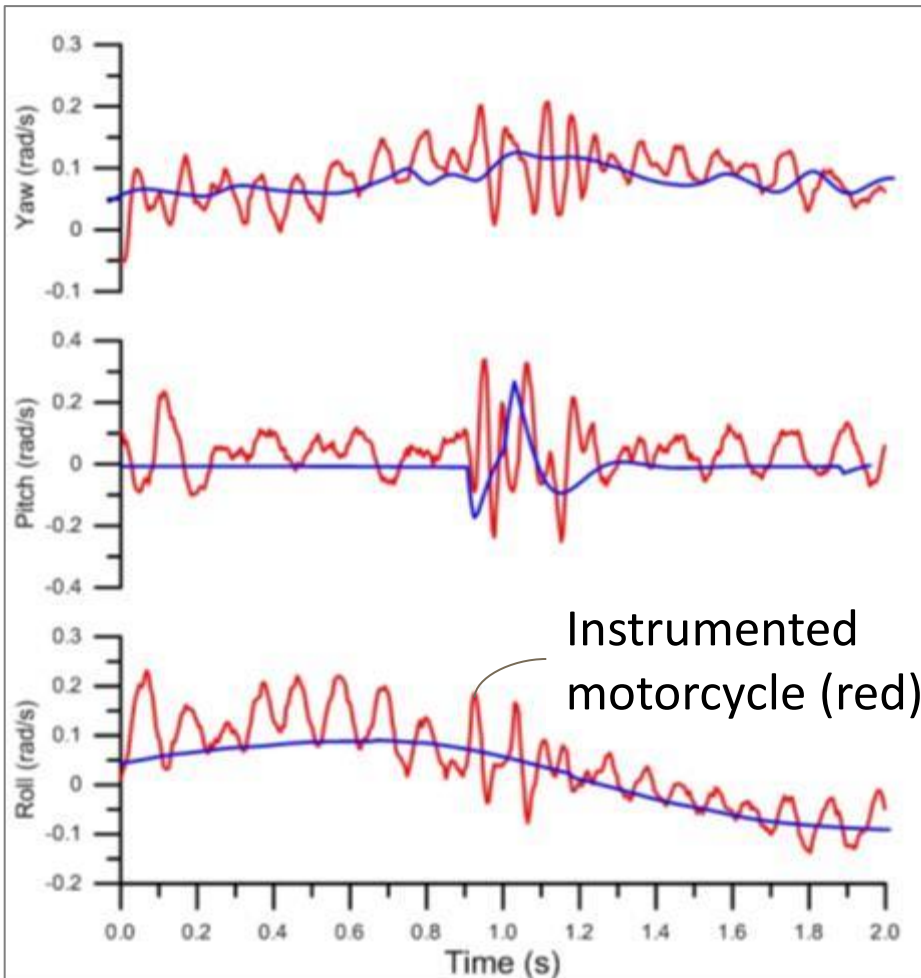
# Response from instrumented motorcycle (red) and PC-Crash (blue)

100 metre radius corner,  
30 km/h  
9 mm high rib

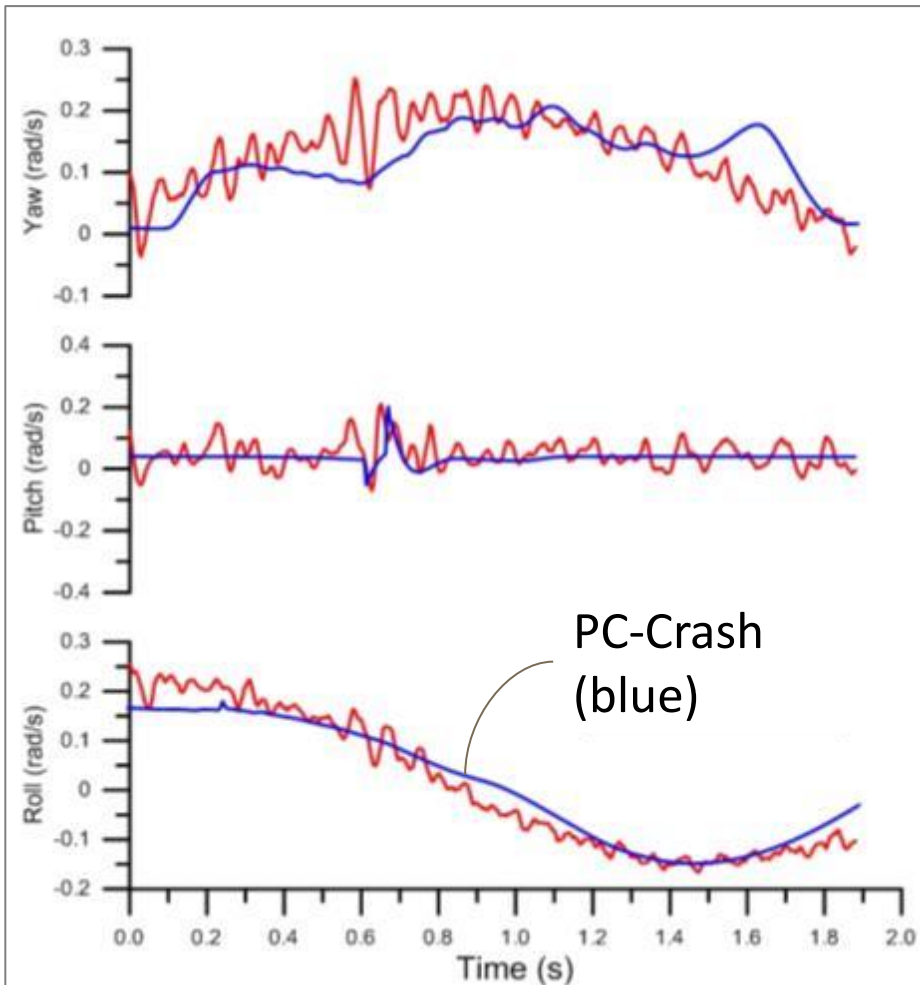
50 metre radius corner,  
30 km/h  
9 mm high rib

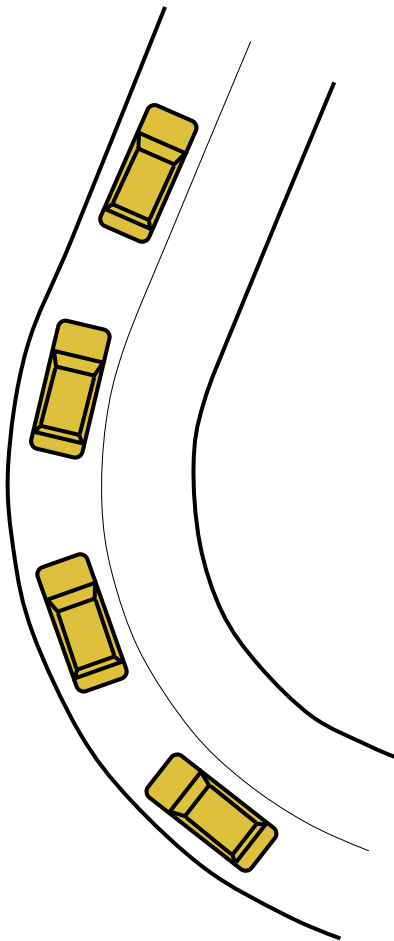
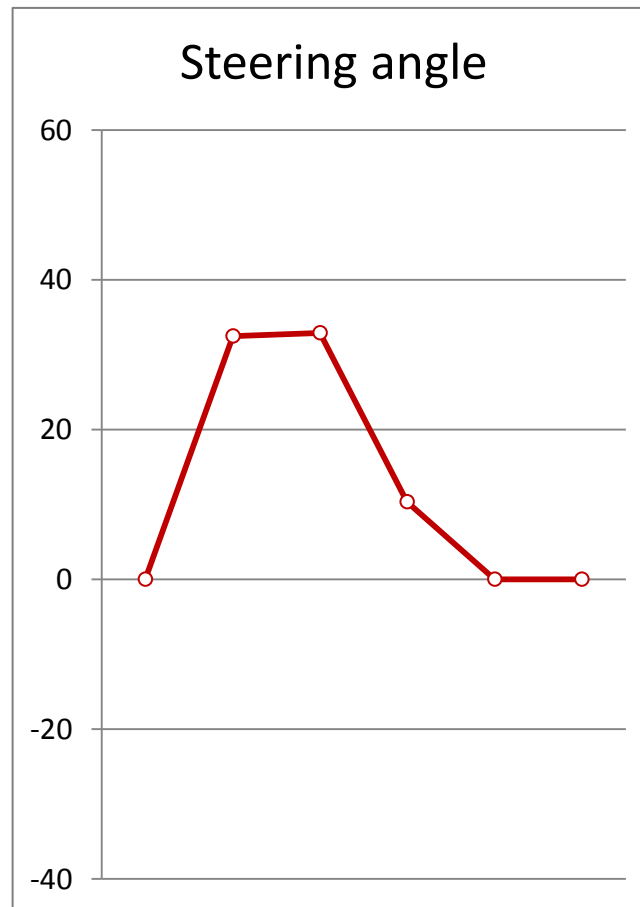
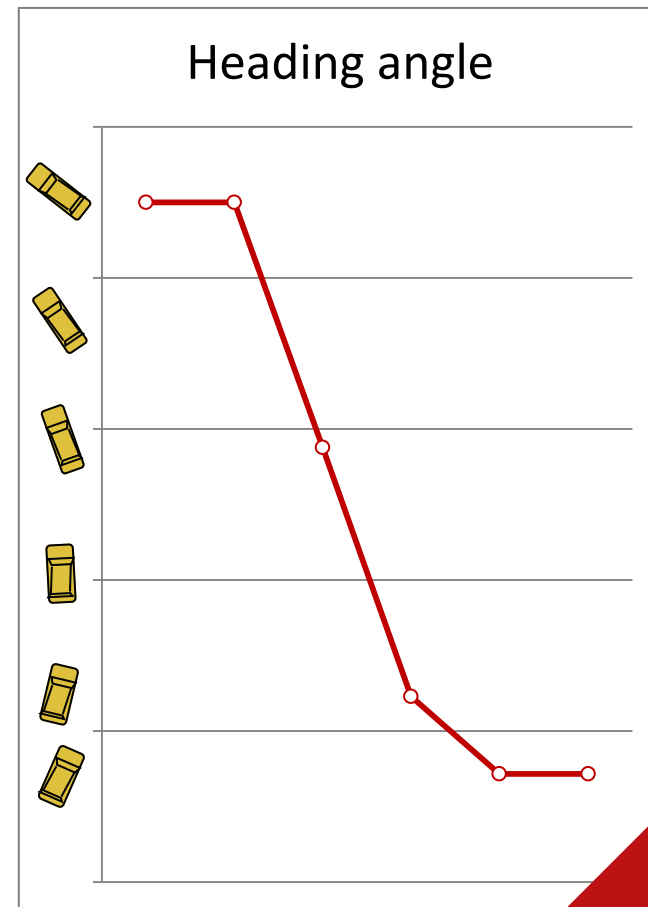
# Steering angles and heading angles

- The plan:
  - Simulate a motorcycle ridden on a road without ATP roadmarkings
  - Simulate a motorcycle ridden on that road with ATP roadmarkings
  - Compare the motorcycle's stability or handling

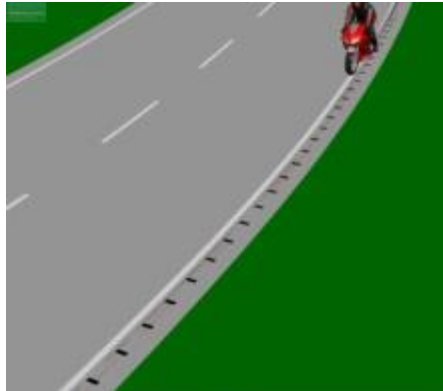
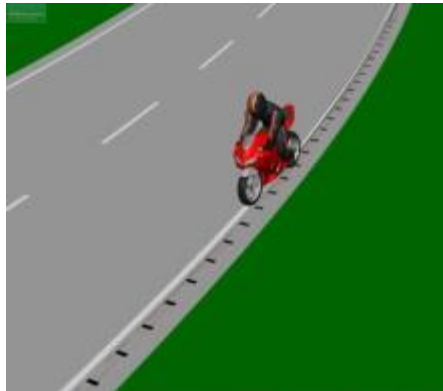
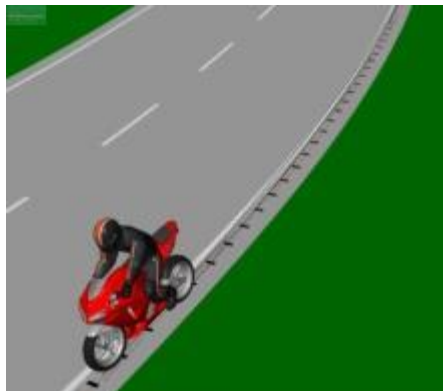
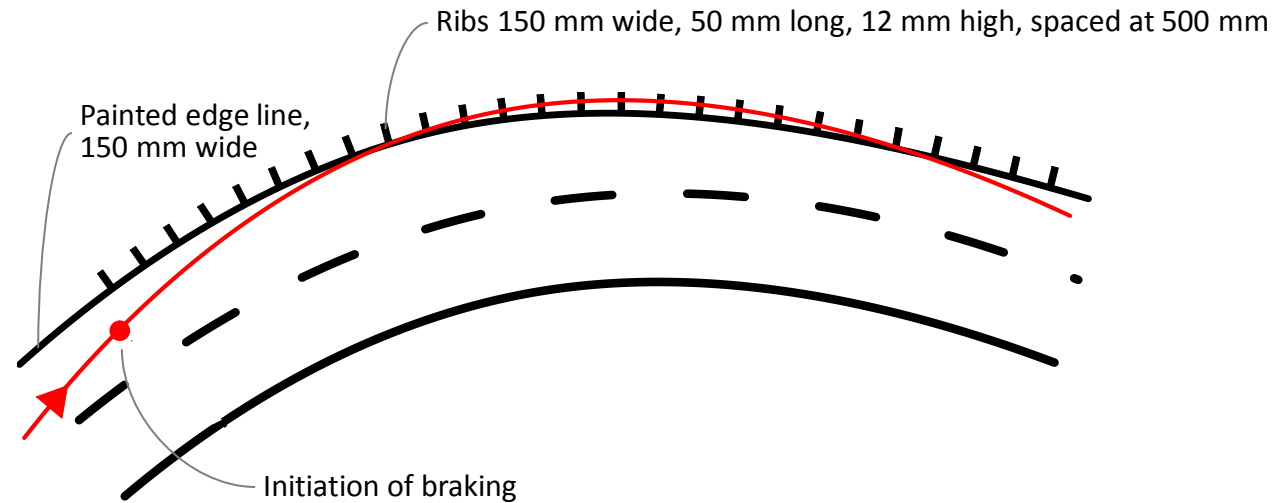
- Wide/poor approach to a “tight” corner
- Wet road surface
- Two speeds
  - 100 km/h
  - 140 km/h
- Three braking scenarios
  - No braking
  - Some braking (50 %)
  - Maximum braking (100 %)

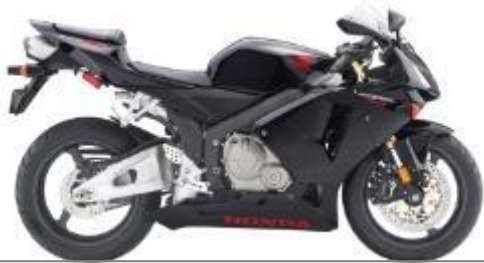
Honda CBR 600RR  
sports bike

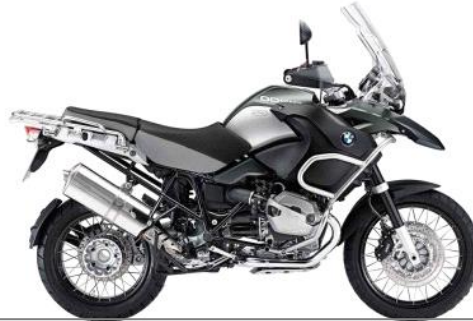
BMW R1200RS  
road/track bike

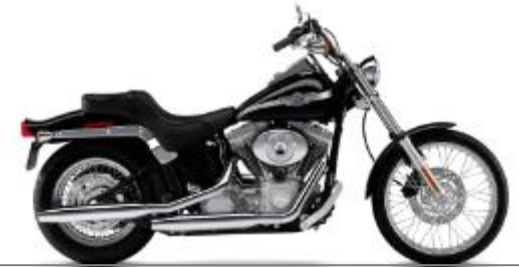
Harley Davidson Softail  
cruising/touring bike

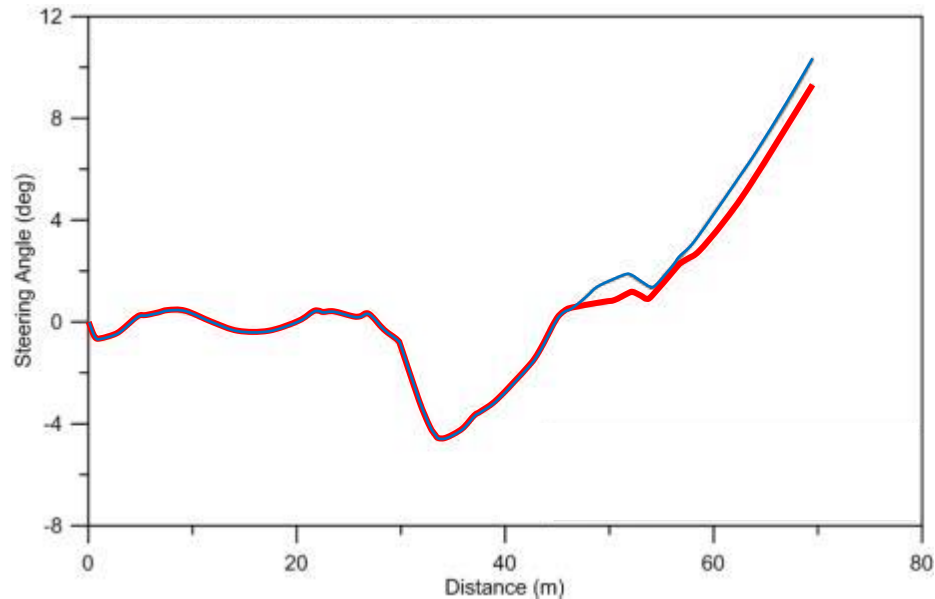
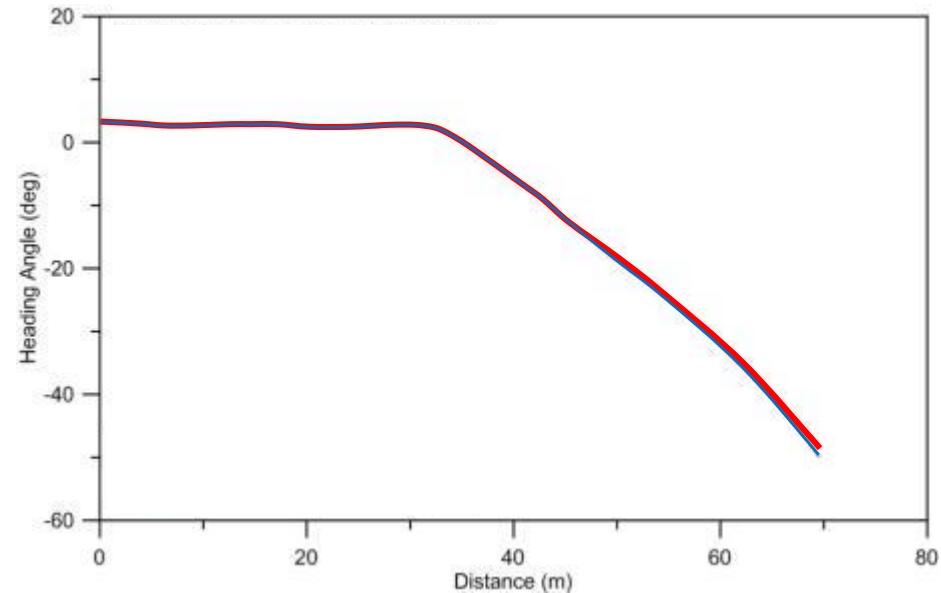
- 100 km/h, 50 % braking, sports bike
- Without ATP roadmarkings (red) and with ATP roadmarkings (blue)
