# Effectiveness of Transverse Road Markings on Reducing Vehicle Speeds

NZTA research report 423

Cherie Mason - Senior Road Safety Specialist

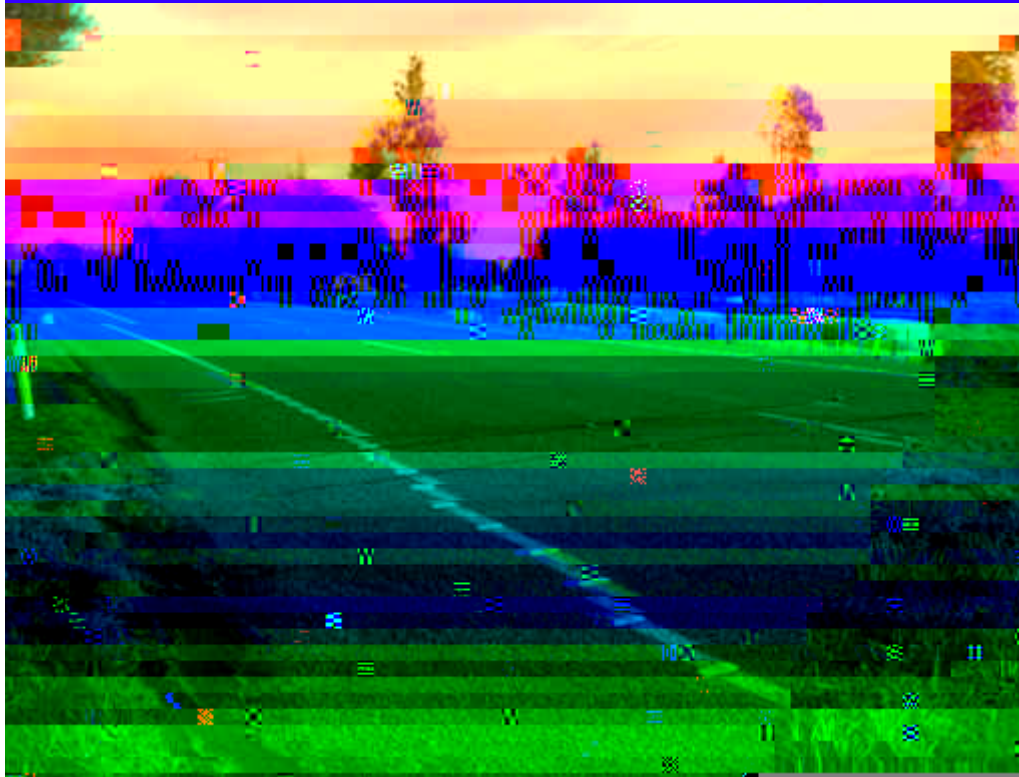
- Site 1 – 410m out from hazard
