NZTA Research Report 526

Stability of motorcycles on audio tactile profiled (ATP) roadmarkings

Neil Jamieson, Bill Frith, Tiffany Lester, Vince Dravitzki

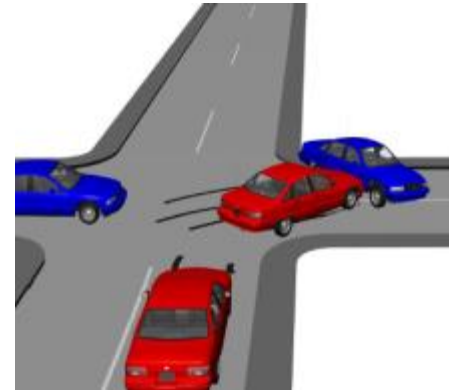
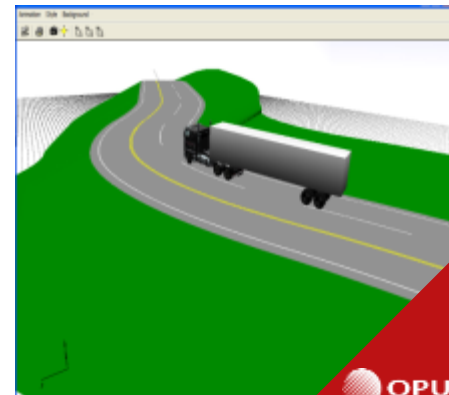
- Vehicle crash and trajectory simulation modelling software: PC-Crash
  - Three-dimensional road element
  - Vehicle manufacturer data on physical characteristics and performance parameters of vehicles
  - For vehicle(s), specify the path to follow during the simulation, with any sequence of speed, acceleration, braking...
  - Kinetic model determines vehicle response during the simulation as the vehicle performs the specified movement as far as possible under application of the laws of physics

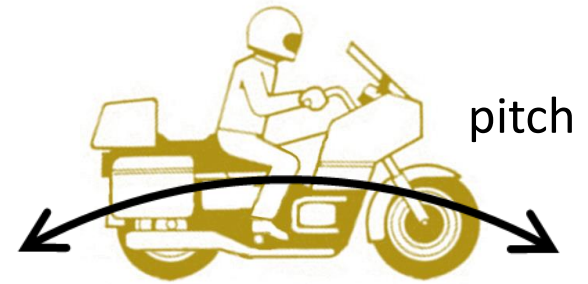
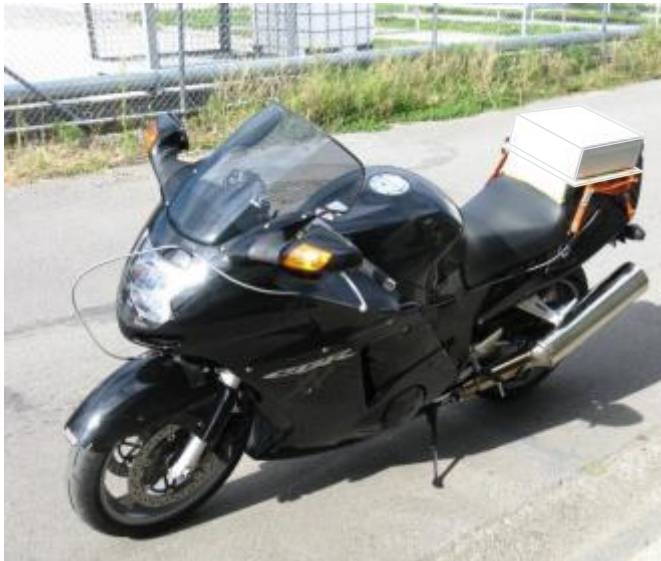
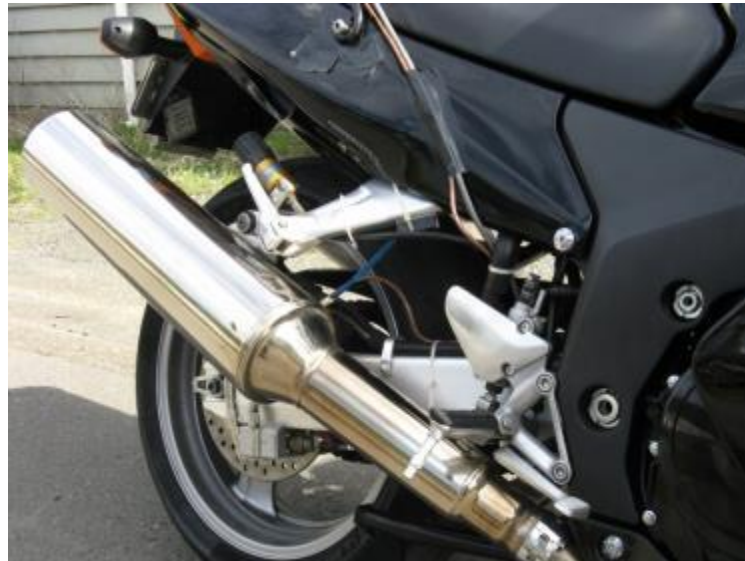
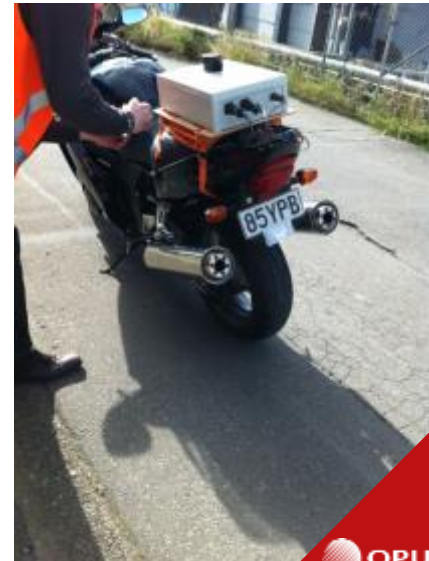
- Verify PC-Crash by comparing with full-scale physical testing
  - Quantities that can be measured by both PC-Crash and a real-life motorcycle

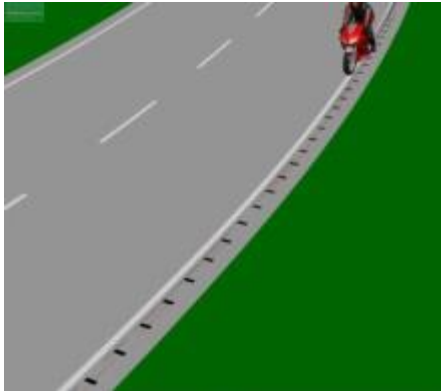
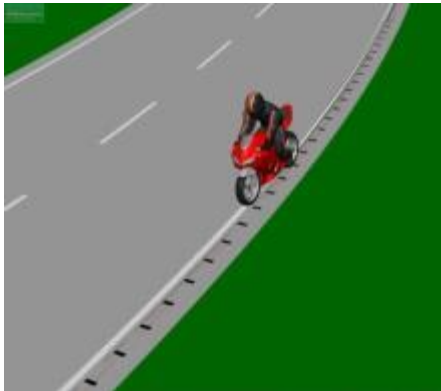
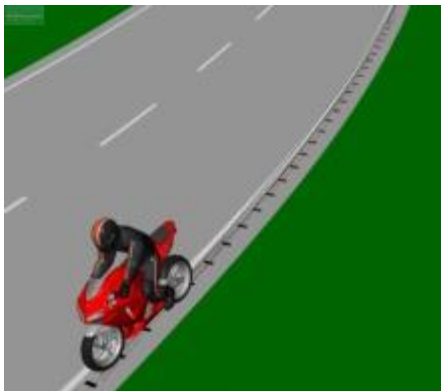
- Wide/poor approach to a “tight” corner
- Wet road surface
- Two speeds
  - 100 km/h
  - 140 km/h
- Three braking scenarios
  - No braking
  - Some braking (50 %)
  - Maximum braking (100 %)

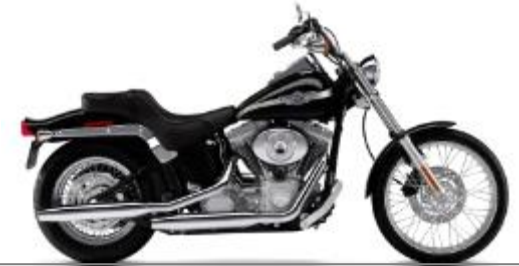
Harley Davidson Softail  
cruising/touring bike
