## Rumbling through the Bay

Are the audio tactile profiled (ATP) roadmarkings still effective?

Presented by Vince Dravitzki, Opus Research

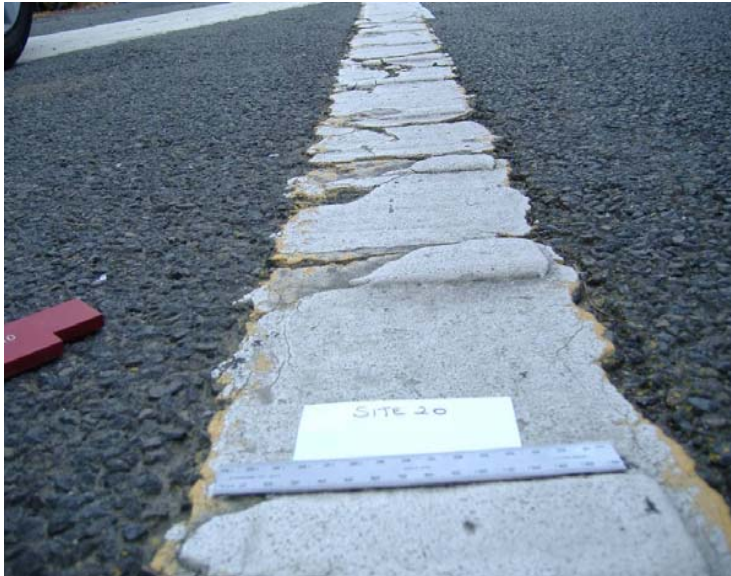
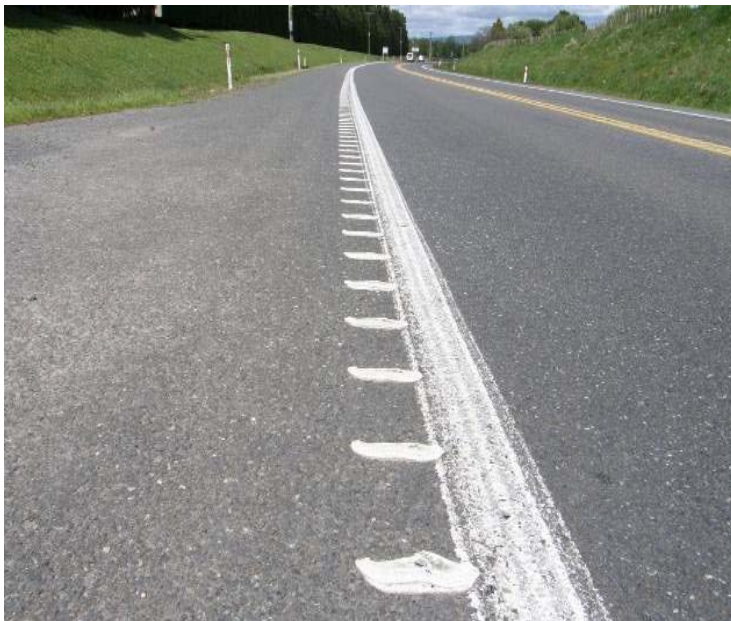
## How ATP markings can deteriorate

- Slow abrasive wear
  - Cold plastic is very hard
- Profile is pushed down into road surface under heavy traffic
- Break-up under wear
- Profiled elements loose adhesion
- Partial breakage when clearing snow falls

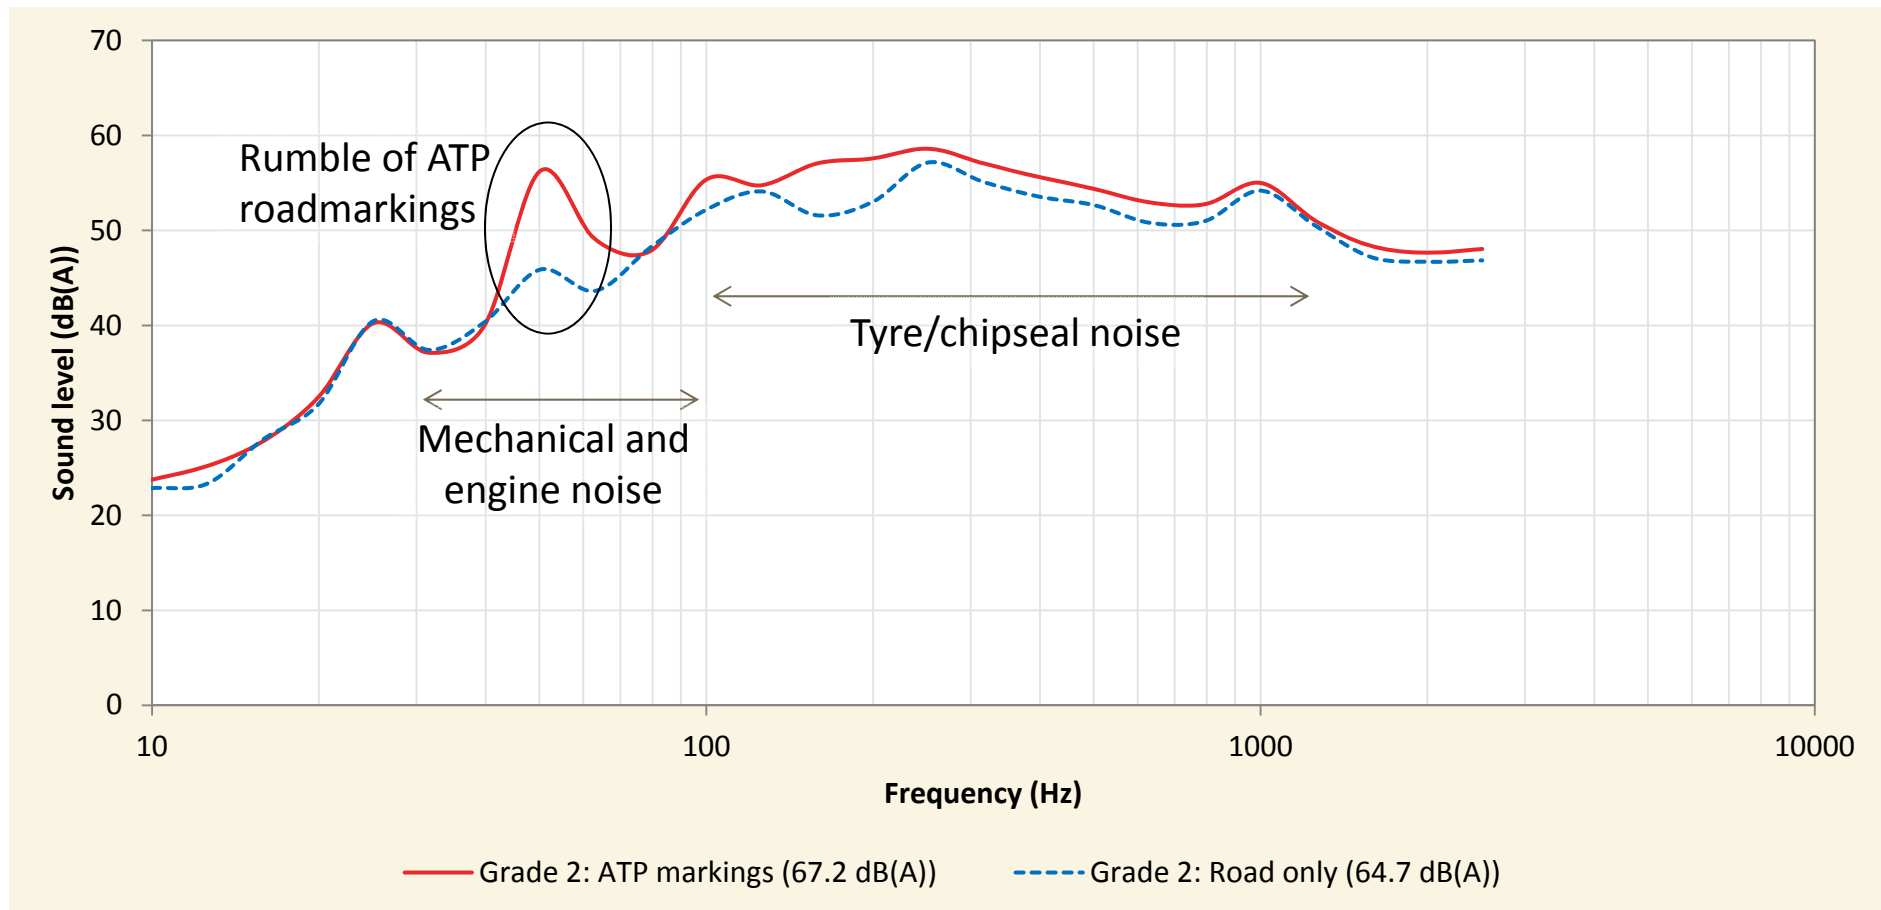
## “Pictures” of noise: car on road only and car on ATP roadmarking

- Road traffic noise is made up of many different components
- Noise spectra show a picture of the noise which help show up these different components of the noise
- ATP roadmarkings work by having a distinct tonal noise

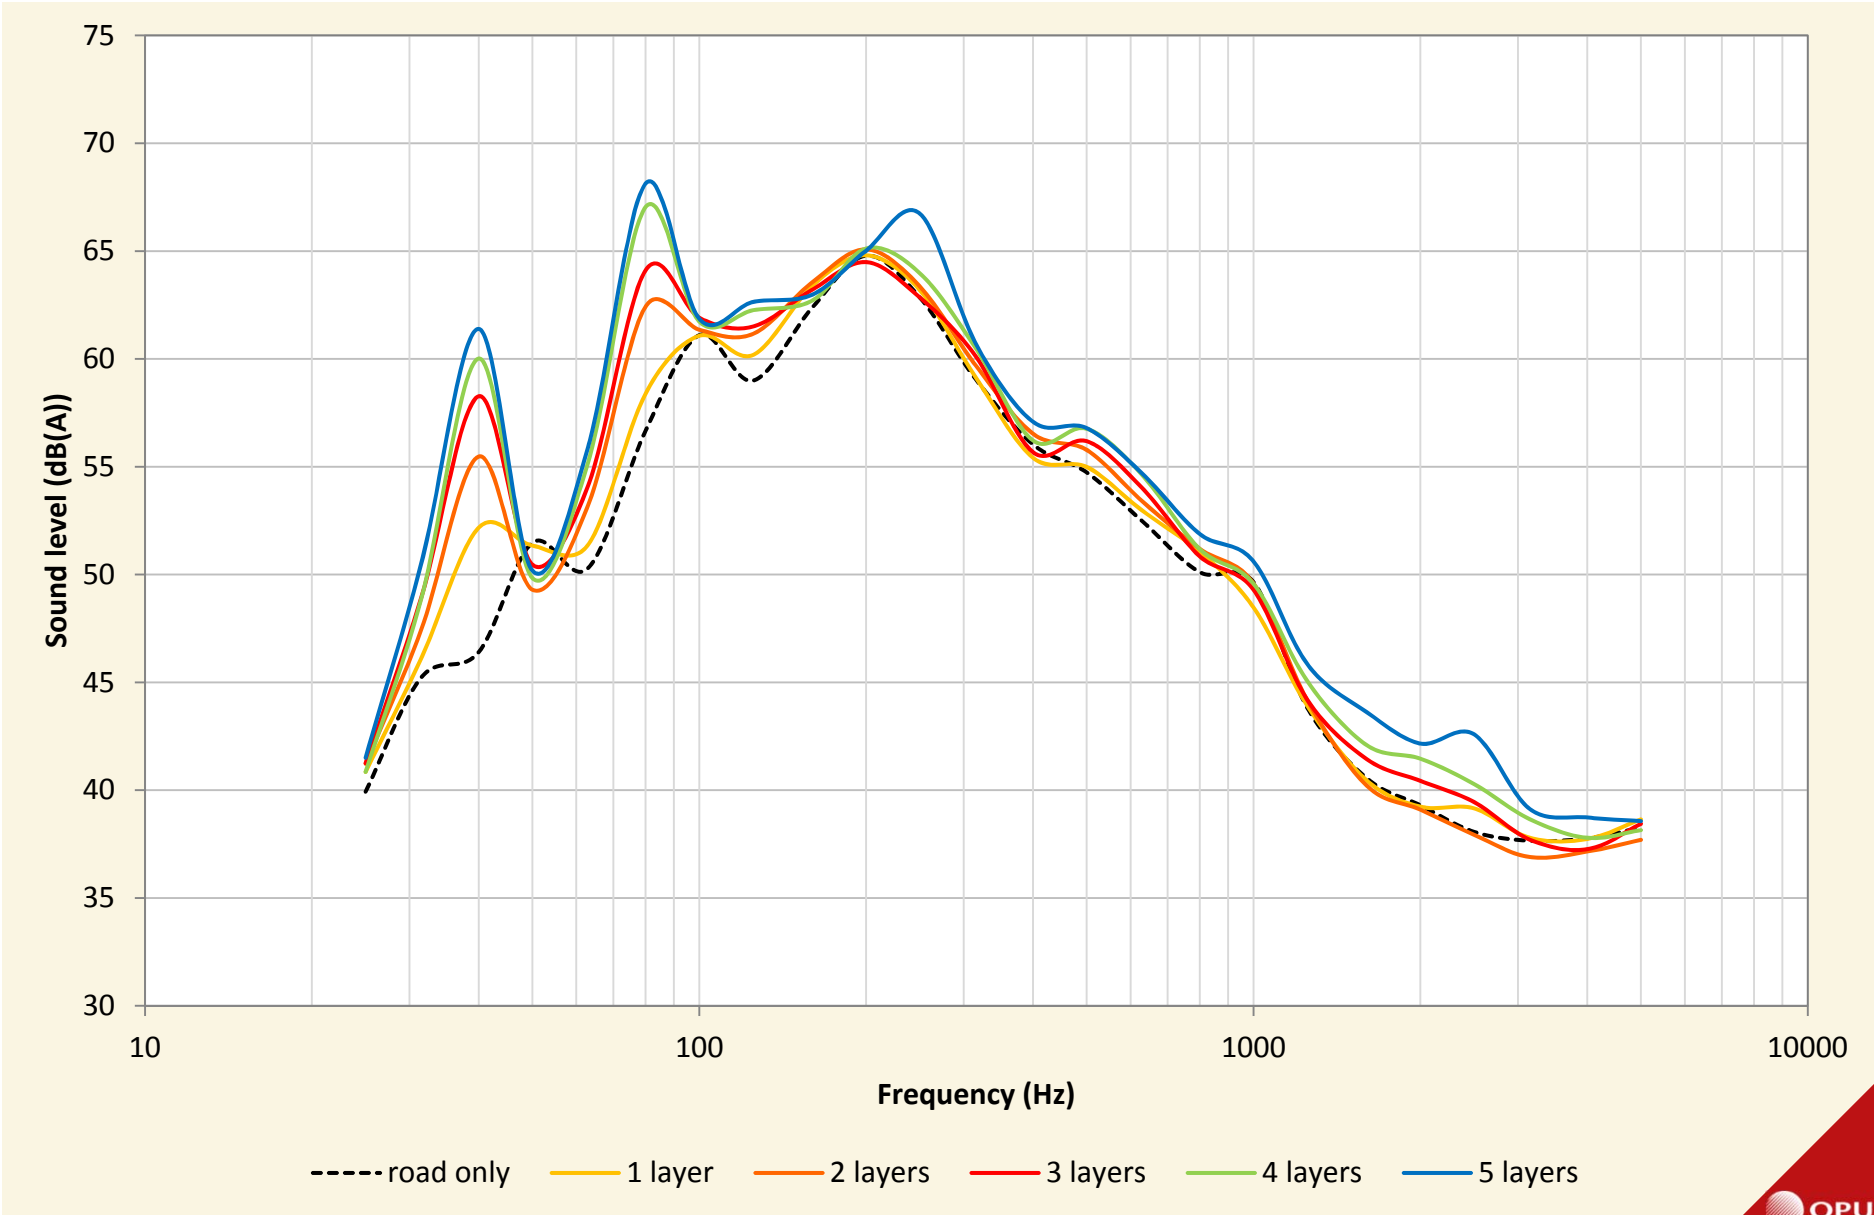
# Review of Project 478: Tonal peaks increase with block height

40 Hz	80 Hz	All Hz
	Increase relative to road only	Increase relative to road only	Total noise
Road only			70.6
1 layer block height	5.8	1.7	71.1
2 layers	9.1	5.8	71.8
3 layers	11.9	7.4	72.0
4 layers	13.6	10.4	73.0
5 layers	15.0	11.5	73.9

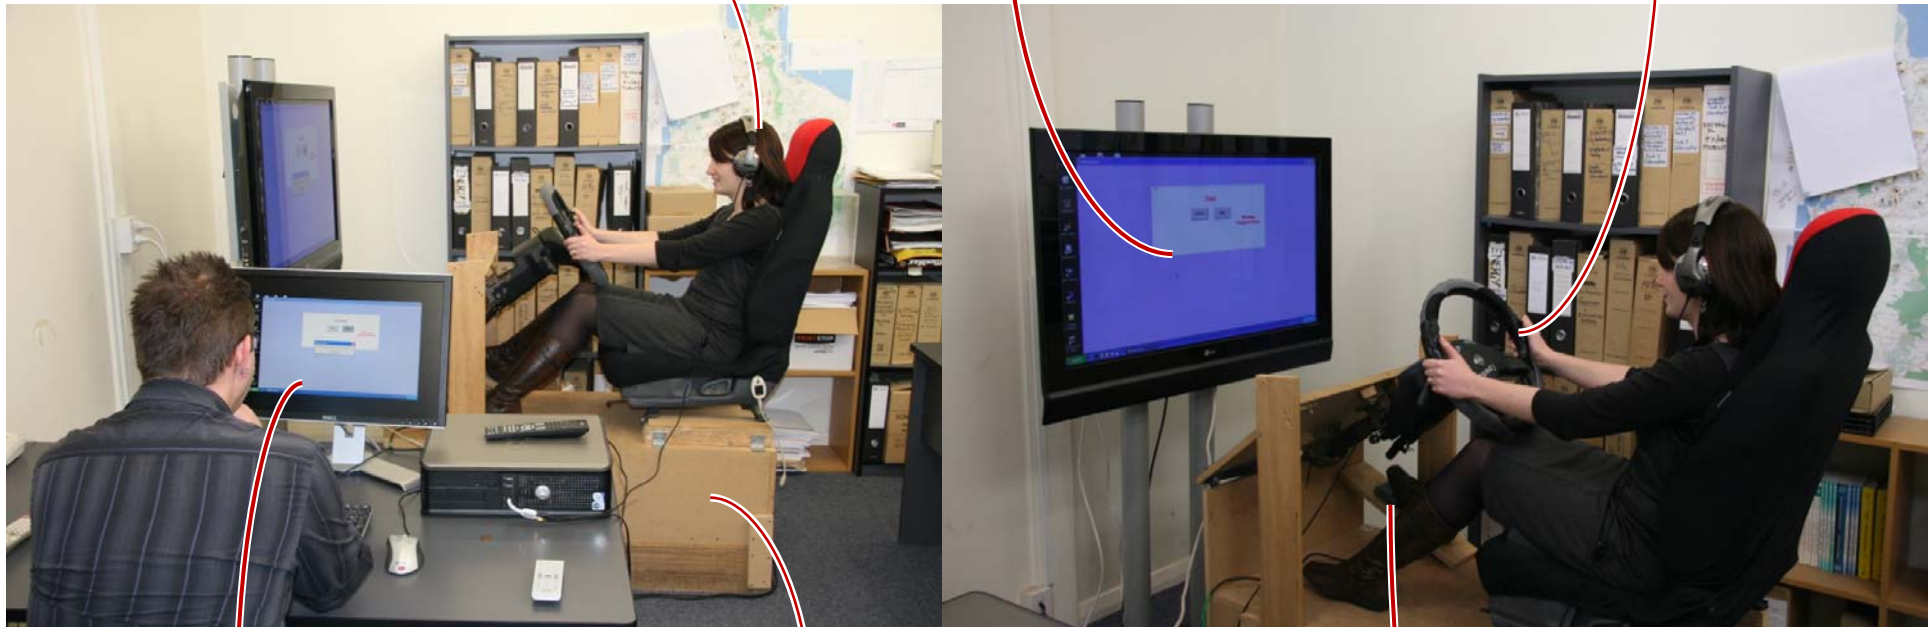
# Review of Project 478 continued (3): Playback in Driving Simulator

## Headphones

Generating ATP marking  
noise (plus music)

Television stimuli  
Showing Stroop test

Steering wheel  
With buttons for participant  
to respond to Stroop test

Computer with operator  
Controlling test

Sub woofer  
Generating vibrations under  
participant's seat

Foot pedal  
For participant to press  
when detecting ATP  
marking

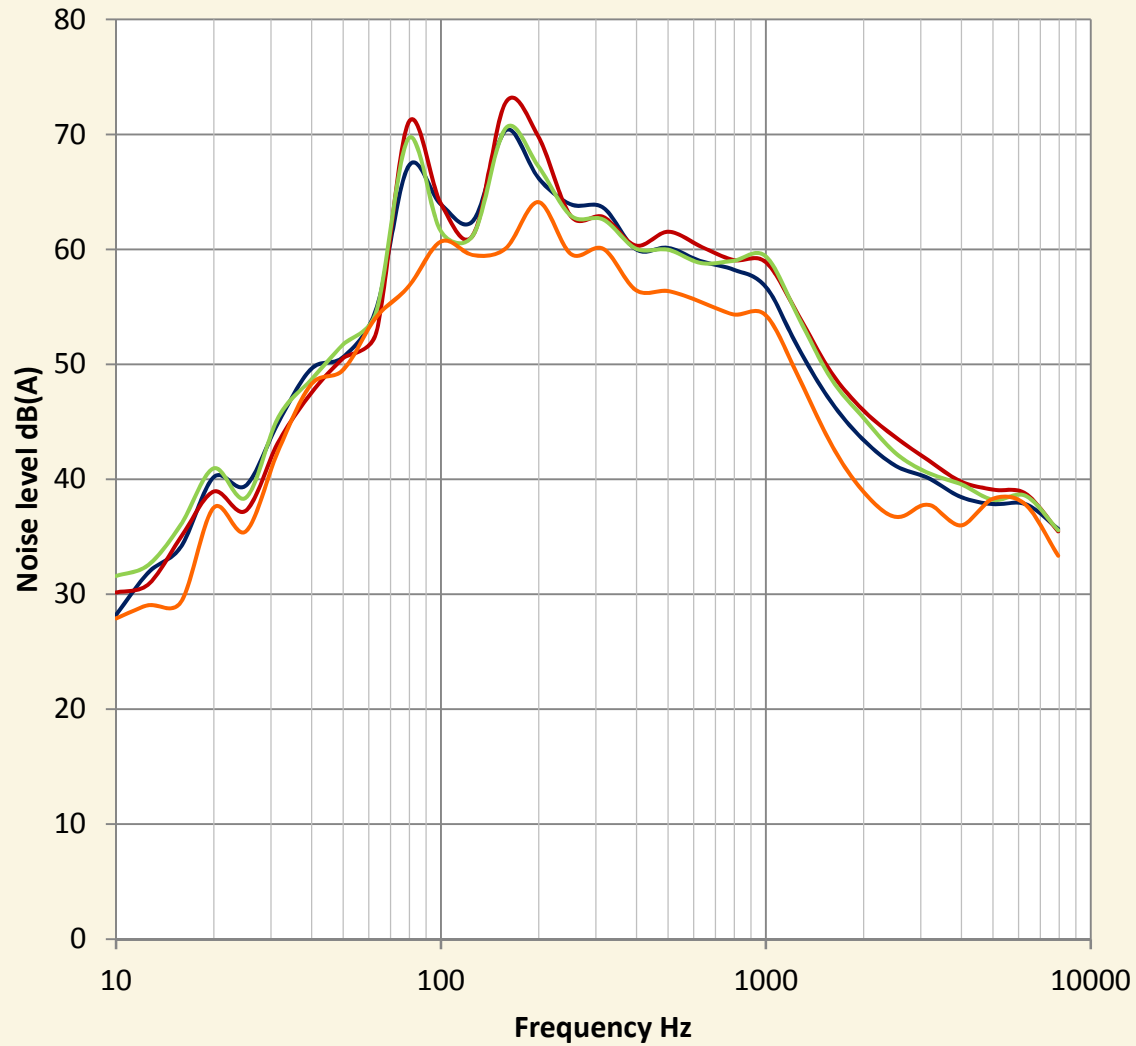
# Overall results

— Straight 75.3      — Outside curve 77.4  
— Inside curve 75.8      — Milled or severe damage 70.2

dB
Straight	75.8
	75.3
	74.9
Outside curve	78.3
	76.3
Inside curve	75.9
	75.6
Milled or damaged	69.7
	70.3

- The results are logical - you would expect the outer corner to be less worn than the inside corner
- There is a distinct difference between ATP roadmarkings and one that is heavily worn (milled)
- These ATP roadmarkings at 4-6 years old are still effective and appear to have a significant remaining life (3-4 years?)
