# Wide Centreline Trial Technical Note

Bridget Burdett, Traffic Safety Engineer, Beca Infrastructure Ltd

New Zealand Roadmarkers Federation Conference

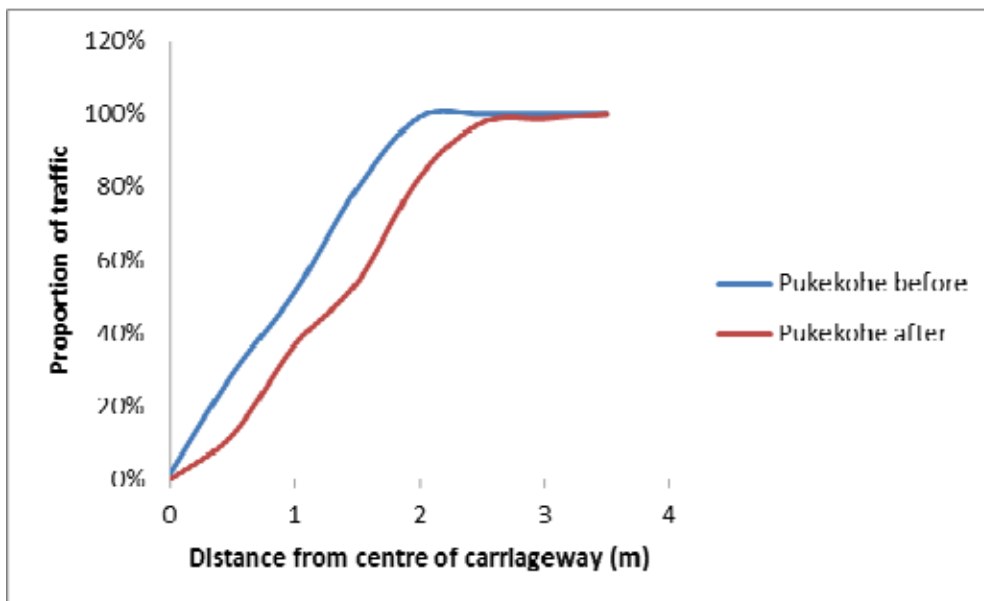
Figure 3 Lateral separation, SH22 Pukekohe

Results from this site show an average *increase* in lateral separation of 0.54m, from 2.5m to 3.0m. The 5<sup>th</sup> percentile separation (those vehicles travelling the closest to the centre of the road carriageway) *increased* from 0.5m to 1.0m.

Lateral separation results for the Pukekohe site are shown in **Figure 3**.

As the trial implementation included removal of a passing lane at the survey location, there was a measured decrease in speed at the trial site. This is unlikely to be related to the change in markings.

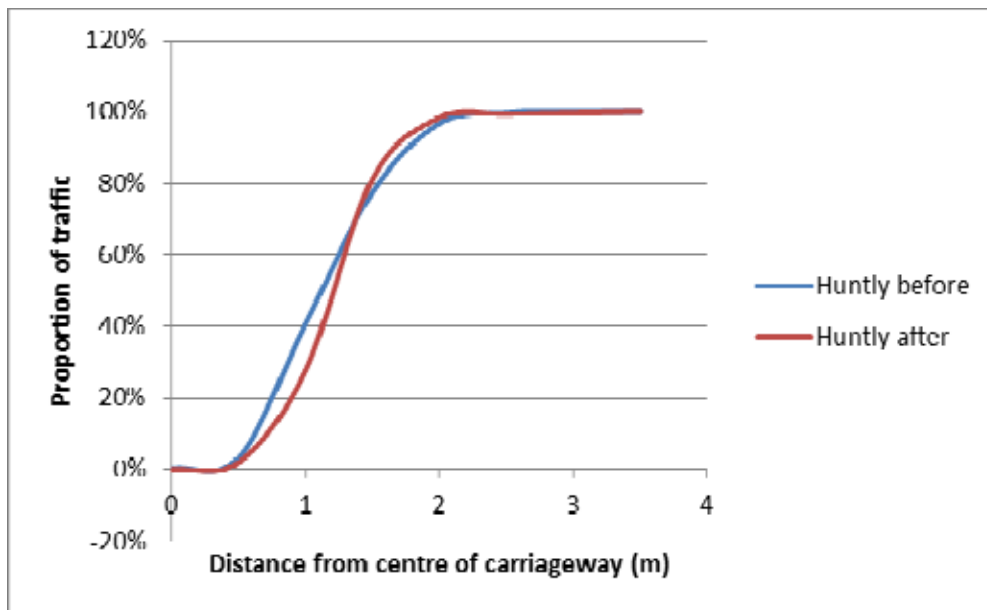
Figure 4 Lateral separation, SH1 Huntly

Results from this site show an average *increase* in lateral separation of 0.19m, from 2.7m to 2.9m. The 5<sup>th</sup> percentile separation (those vehicles travelling the closest to the centre of the road carriageway) *increased* from 1.6m to 2.0m.

Lateral separation results for the Huntly site are shown in **Figure 4**.

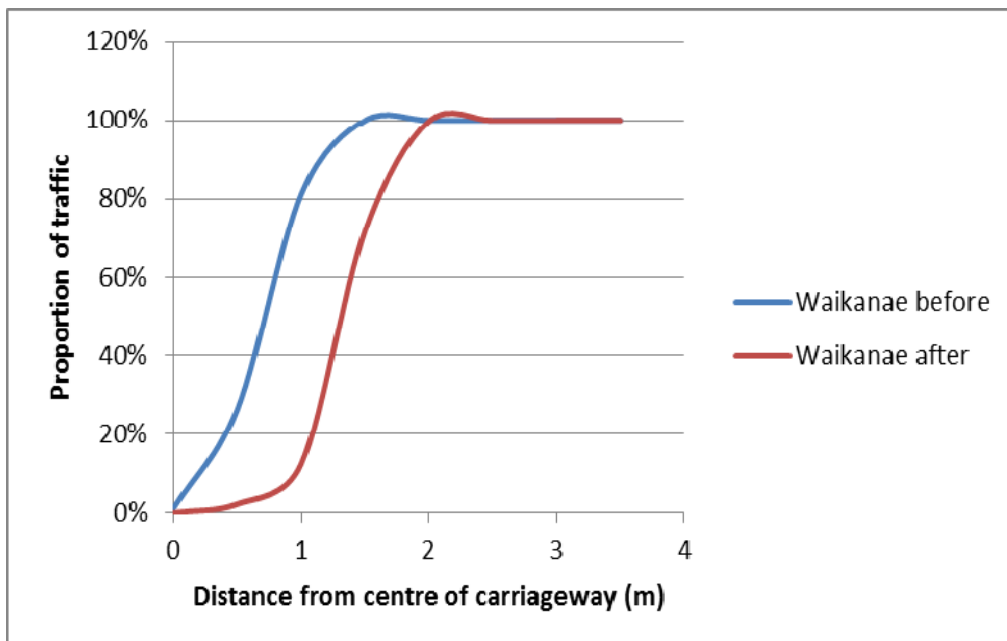
Figure 5 Lateral separation, SH1 Waikanae

Results from this site show an average *increase* in lateral separation of 1.4m, from 1.7m to 3.1m. The 5<sup>th</sup> percentile separation (those vehicles travelling the closest to the centre of the road carriage way) *increased* from 0.8m to 2.0m.

Lateral separation results for the Waikanae site are shown in **Figure 5**.

All sites showed a significant increase in lateral separation of opposing traffic. However, it is interesting to note the wide range of separation changes, from an increase of around 0.2m at two sites, to a relatively large increase of 1.4m at the Waikanae site. Further analysis of differences between the treated sites (for example, the type of markings installed and the width of the median, traffic lanes and shoulders) may provide reasons for these differing results.
