# Wide Centreline Trial Technical Note

Bridget Burdett, Traffic Safety Engineer, Beca Infrastructure Ltd

New Zealand Roadmarkers Federation Conference

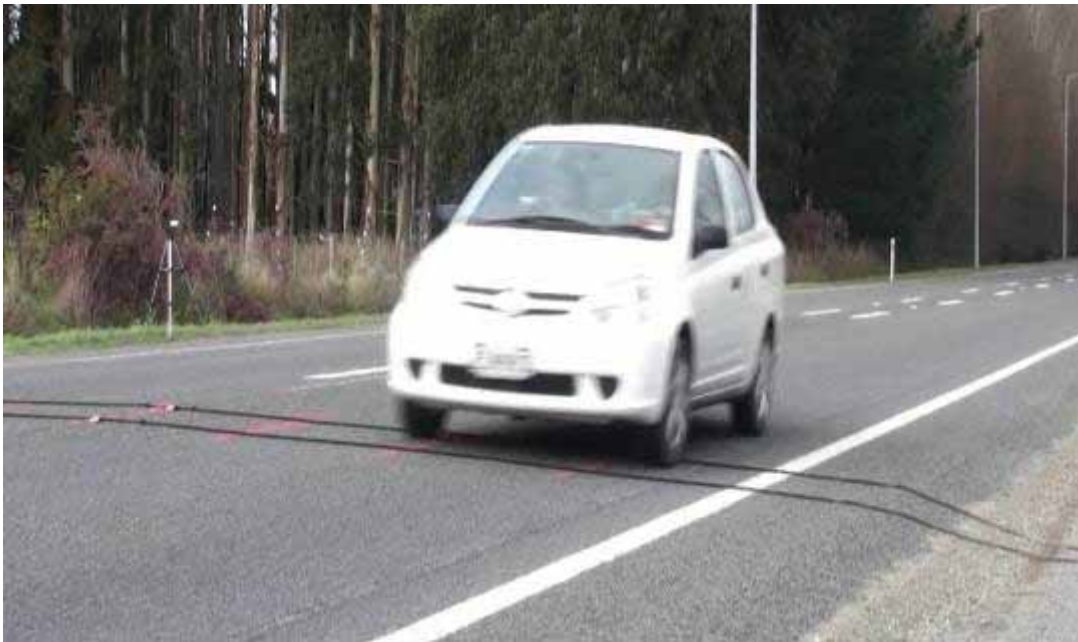
**Figure 2 Example lateral position still shot**

Vehicle position was measured from the video data, using motion-capture software to convert the video to a series of still shots. Only vehicles with at least a five second headway to the vehicle in front were captured, to avoid effects of following on lateral position. An example still shot is shown in **Figure 2**.

To determine whether the trial resulted in a change in vehicle position relative to the centre of the road carriageway, video surveys were carried out for four hours in each direction at each site, before and after the markings were changed. The surveys were carried out on weekends and weekdays (two hours per survey). The surveys coincided with the speed surveys, so that the pneumatic tubes themselves could be used to help calibrate the video, and so that data could be coordinated between the two surveys if required. The speed tubes were marked at 1.0m intervals to help calibrate the resulting lateral position data.

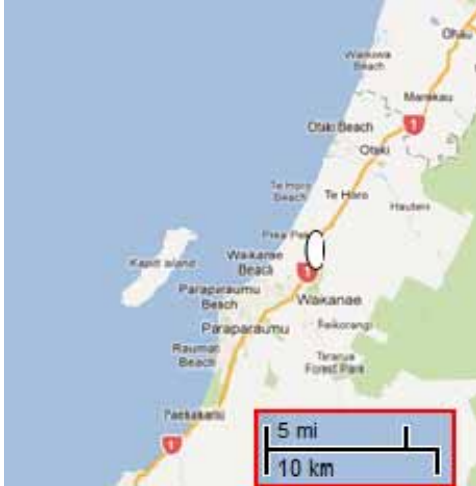
The trial site north of Waikanae (SH1N RP 1012/2.310 – 1012/3.712) started at the 100km/h speed change north of Waikanae and extends north for approximately 1.4km.

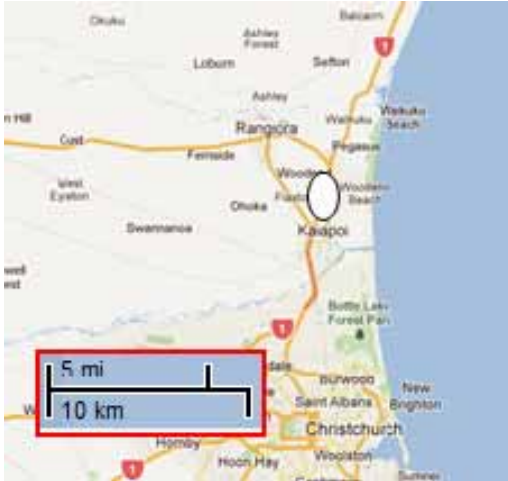
The trial site south of Woodend (SH1S RP 317/200 – 317/2200) starts north of the junction with SH71 and ends south of the township of Woodend, as shown below.

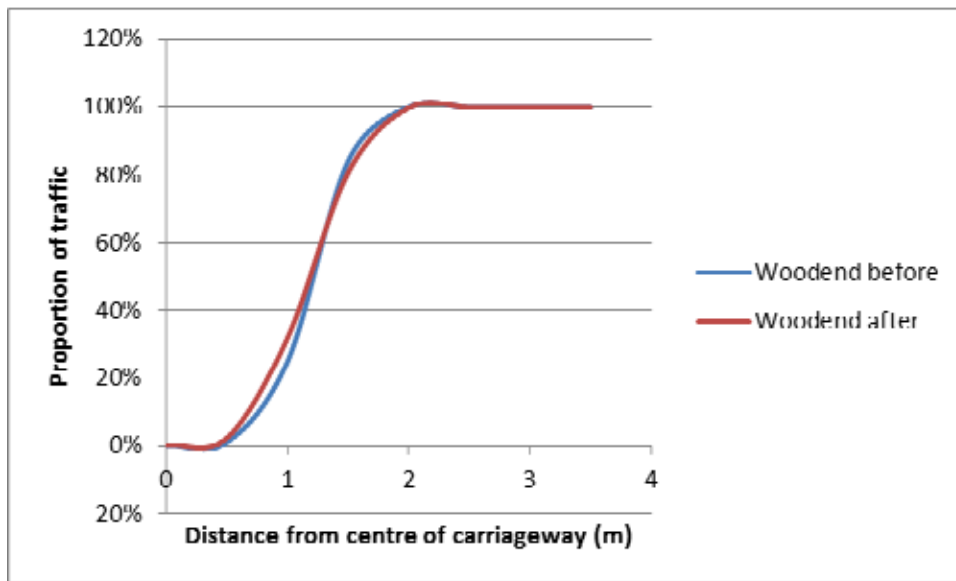
Figure 6 Lateral separation, SH1 Woodend

Results from this site show an average *increase* in lateral separation of 0.14m, from 2.6m to 2.8m. The 5<sup>th</sup> percentile separation (those vehicles travelling the closest to the centre of the road carriageway) *decreased* from 1.8m to 1.3m.

Lateral separation results for the Woodend site are shown in **Figure 6**.

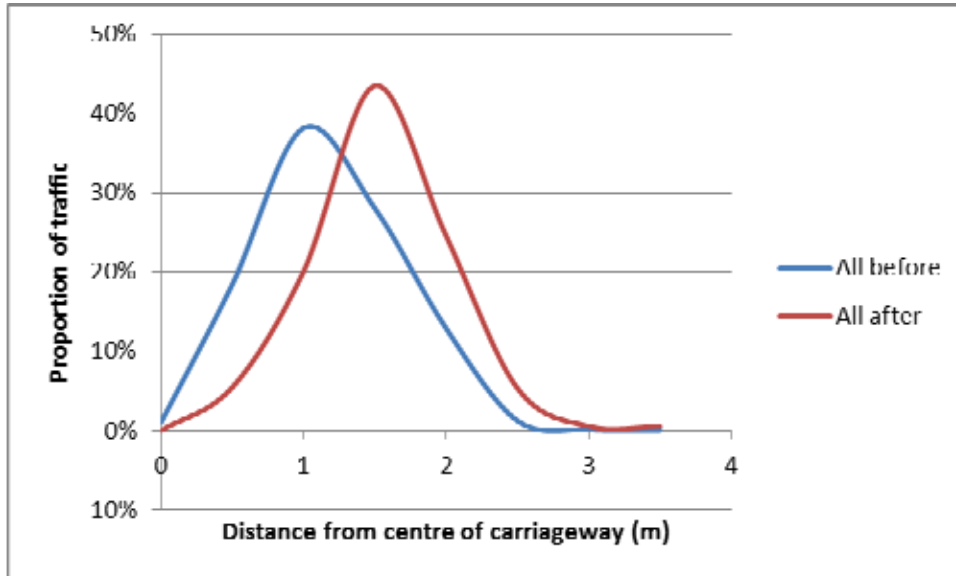
Figure 7 Distance from centre of carriageway – before and after

Though all sites are different in terms of marking type and lane dimensions, the combined change in distance from the centre of the road carriageway shows a significant increase from 1.2m to 1.5m subsequent to implementation of the wide centreline (**Figure 7**).
